# UBC Vancouver Green Rainwater Infrastructure Mapping and Asset Management

Prepared by: Eric Fang, Heather Li, Jessy Lin, and Ewan Painter  
Prepared for: UBC SEEDS and UBC Campus + Community  
Planning  
ENVR 400: Community Project in Environmental Science  
The University of British Columbia

April 13<sup>th</sup>, 2025

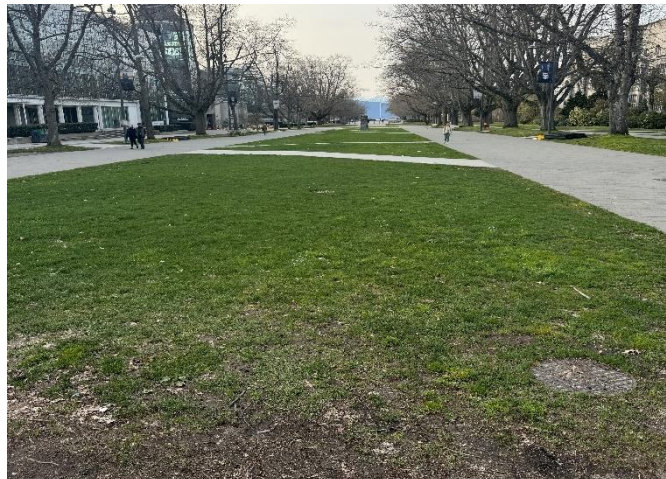
Strong integration with large, catchment-level gray infrastructure helps to capture excess rainwater beyond the infiltration capacity of the lawn. The main mall bioswale (Figure 8), for instance, implements drains intermittently spread across each segment of the lawn to increase infiltration capacity of the system. The actual depression gradient of the bioswale is rather shallow. The amount of green space on campus (even beyond GRI) and the connectivity of these spaces also contributes to vegetative and soil health even without a coordinated management plan specific to GRI.

**Figure 8.** A section of the bioswale on Main Mall.

- Analyze the infiltration rate and performance of GRI that experienced water pooling during rainfall events such as the bioswale along Main Mall.
- This is to ensure that UBC remains prepared for increased severe rainfall events and to minimize the possibility of flooding.
- Timeline: Begin planning over the summer, begin data collection in the fall during heavy rainfall event season (October to December).

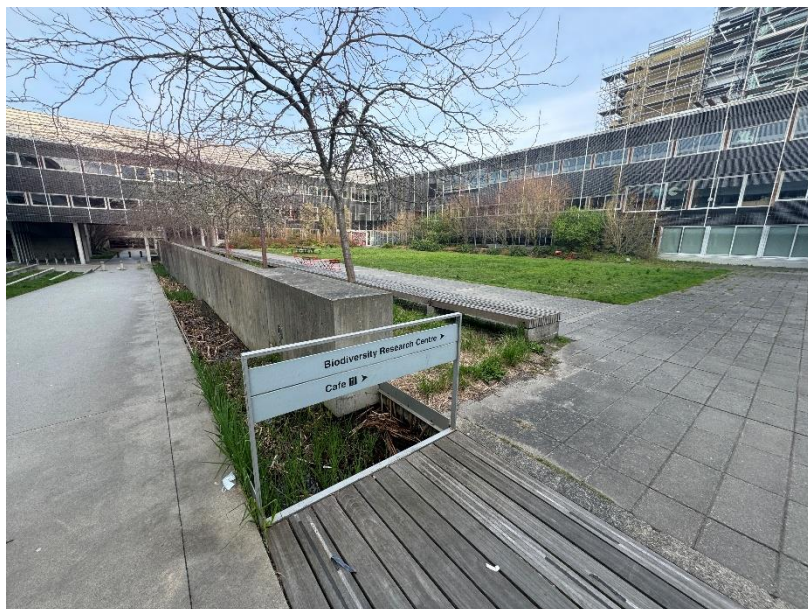
Management of GRI at UBC follows the same procedures as generalized vegetative areas. In preparation for snowfall, several larger GRI were extensively trimmed, including the drainage channel leading from the Beaty Biodiversity Museum green roof (Figure 9). This trimming serves no ecological purpose. In fact, fast-growing invasives may gain a foothold as these plots regenerate.

**Figure 9.** Beaty green roof, showing trimming of wetland vegetation in drainage channel on left.
