# RE-IMAGINING THE STANLEY PARK SEAWALL: AN EXPLORATION OF LIVING SHORELINE ALTERNATIVES

Prepared by: Brontë Mutukistna Sustainability Scholar, August 2022

Francisca Olaya Nieto, Environmental Planner Environmental Planning and Sustainability, Vancouver Board of Parks and Recreation

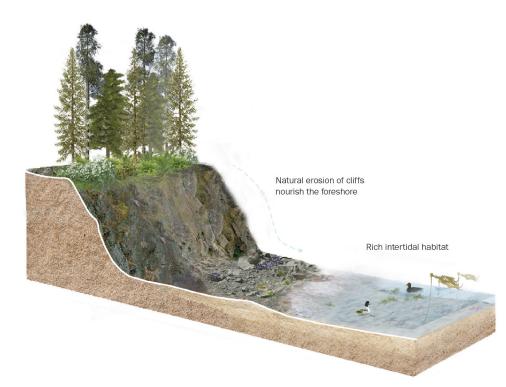
The seawall is a near-vertical stonewall made of rock and mortar, and backfilled with varying materials including rock, broken concrete, and gravel. The height of the seawall along Stanley Park varies from 0.5m to 4.0m and spans 8.8km around the park (KWL, 2017). Beginning construction in 1917, the seawall was originally built to prevent coastal erosion, but the wall's path has now become one of Vancouver's most popular tourist attractions. While the seawall provides recreational benefits and uninterrupted coastal access, the armouring of the shoreline has severe repercussions on nearshore habitats and worsens resilience to rising sea levels and storm events by limiting the natural ability of the shoreline to mitigate flooding and erosion.

Before Seawall

After Seawall

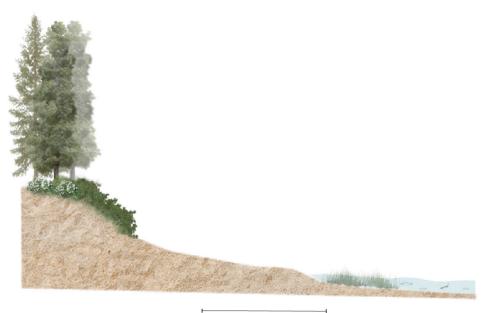
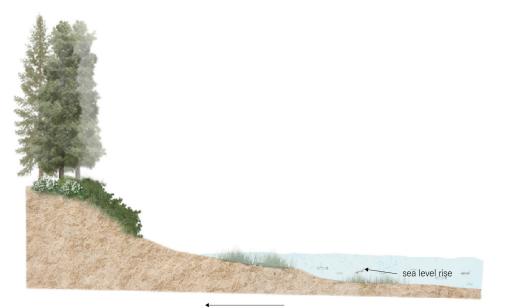
INTERTIDAL ZONE

Intertidal zone moves landward

seawall prevents migration of intertidal zone

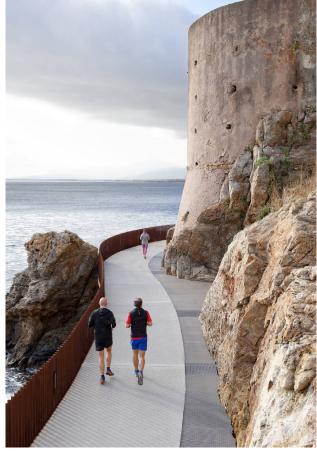
Designed by Dietmar Feichtinger Architectes and Buzzo Spinelli Architecture, the promenade Aldilonda is a 450m long pedestrian and cyclist walkway that wraps around the rocky coastline at the base of the Citadelle in Bastia. Nestled into the rock, the promenade sits 5 meters above sea level, bringing visitors over the Mediterranean and providing a rare sense of immersion between the cliffs and the sea (Dietmar Feichtinger Architectes, 2021). The softly curved pathway contrasts the sharp cliffs, yet the construction seamlessly blends into the landscape. The reddish hue of the Corten steel railings mirror the natural colouring of the iron-rich rock and the Citadelle's architecture (Novakovic, 2021). The structure is designed to withstand wave exposure and flooding. The Corten steel railings are spaced at 110mm apart and perforated metal grates are placed around the cliff wall, allowing water to naturally flow through the structure during periods of flooding (Dietmar Feichtinger Architectes, 2021). These design elements reduce the force of the water onto the structure and soften the reflection of the waves back onto the ocean floor.

Figure 17 (top) & 18 (bottom): Pathway nestled into rock face, photograph by David Boureau, (2021).

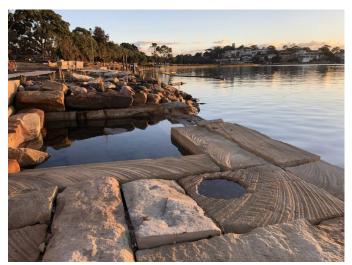
Figure 19: Constructed rock pools, The Leader, ( n.d.).

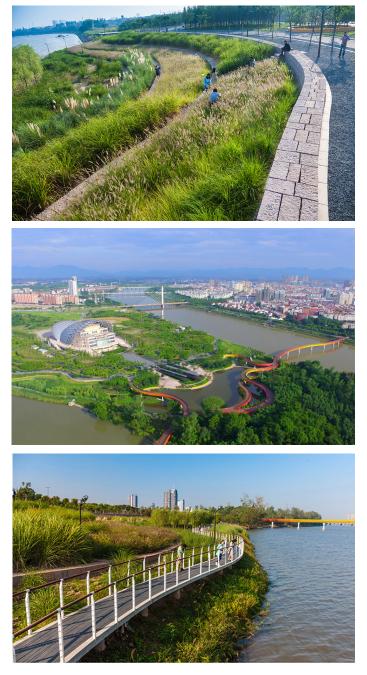
Located at the mouth of 3 rivers, Yanweizhou Park is a 26-hectare wetland park designed by Turenscape. Situated in Jinhua, an area prone to annual flooding due to its monsoon climate, the park was previously surrounded by a concrete flood wall that exacerbated annual flooding and destroyed the dynamic wetland ecosystem (Landezine, 2015). Turenscape's design aimed to remove the ecologically destructive wall whilst still providing flood protection. The flood wall is replaced with a terraced, vegetated embankment that absorbs and slows down floodwater (Hobson, 2015). Rather than working against natural flooding, the design uses the nutrients from the floodwater to support the growth of vegetation, lending to a landscape that requires no fertilization or irrigation. The terrace additionally filters stormwater from the pavement before entering the river (Figure 21). A 5-metre-wide bridge crosses over the two rivers, connecting the southern and northern city districts and linking the city with the park (Landezine, 2015). The bridge is elevated above the 200-year flood level allowing year-round pedestrian access, whilst other sections of the park are temporarily submerged. A network of pathways and boardwalks connect visitors with riparian vegetation (Figure 23).

Figure 21 (top): Vegetated terrace, Turenscape, (2015). Figure 22 (middle): Flood-adapted, elevated boardwalk, Turenscape, (2015). Figure 23 (bottom): Aerial view of park during dry season, Turenscape, (2015).

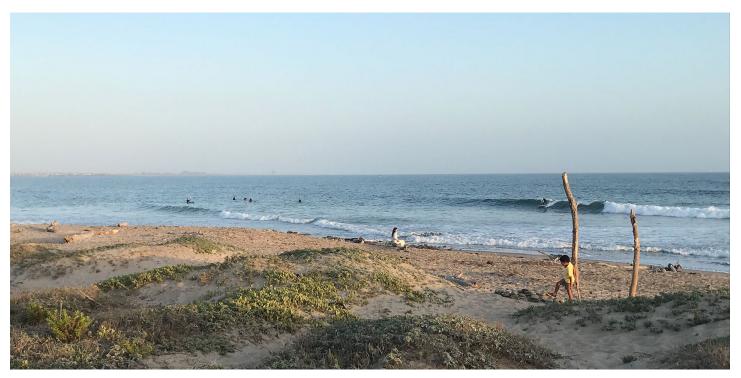
Figure 32: Vegetated dunes, ESA (n.d.).

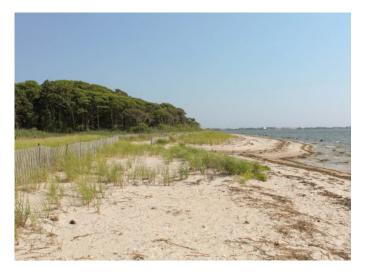
Figure 33: Cordgrass plantings to prevent beach erosion, photograph by Anuradha Varanasi, (2019).

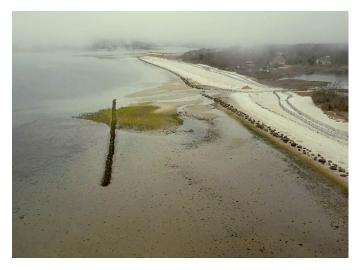
Figure 34: An aerial view of the oyster reefs during low-tide, photograph by Matthew Ballard (n.d.).

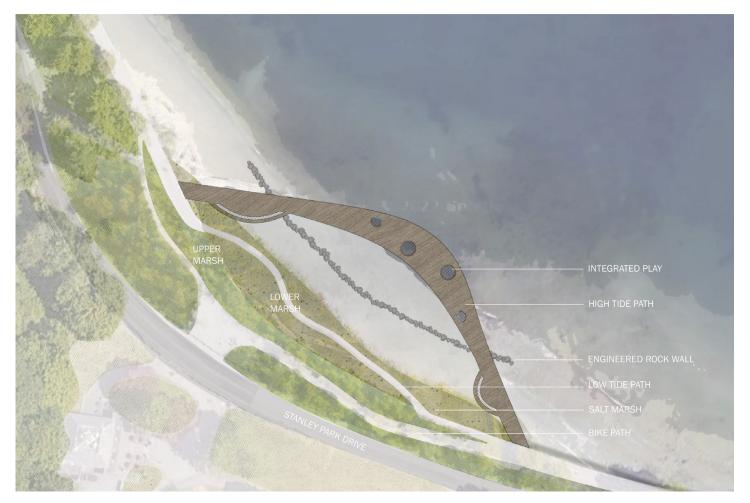
Figure 39: Proposed site plan

+ Netted playground elements allow park users to look below at the intertidal zone, observing species and bivalves, educating users on culturally important resources for Indigenous communities. Potential to pair this with informative signage to pass on knowledge of the significance of this site for the MST Nations.

+ The bike path is elevated and located on a berm providing protection during high tide.

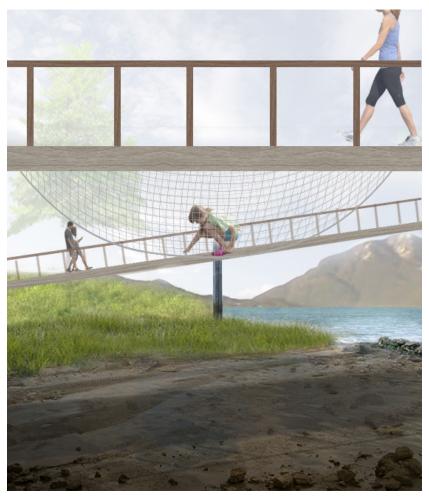
Figure 41: Netted playground supports educational play

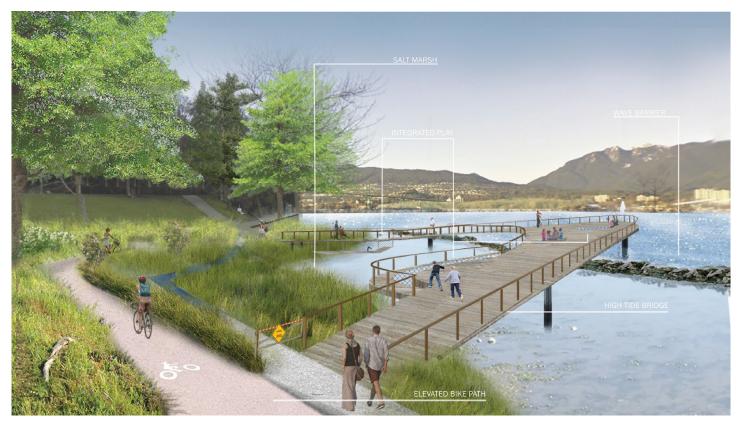
Figure 42: Site during high tide

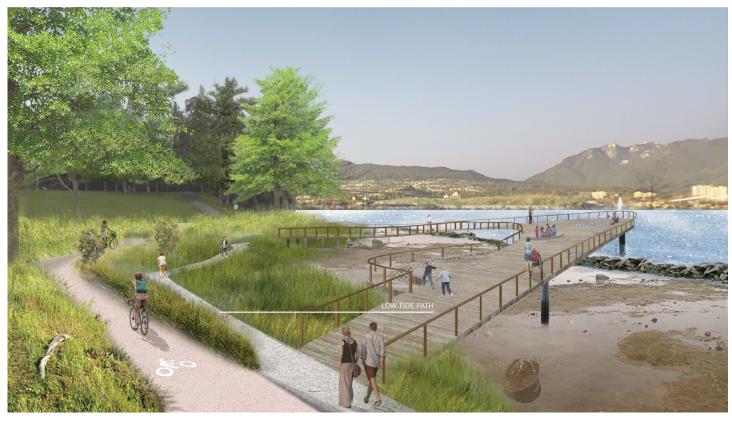
Figure 43: Site during low tide

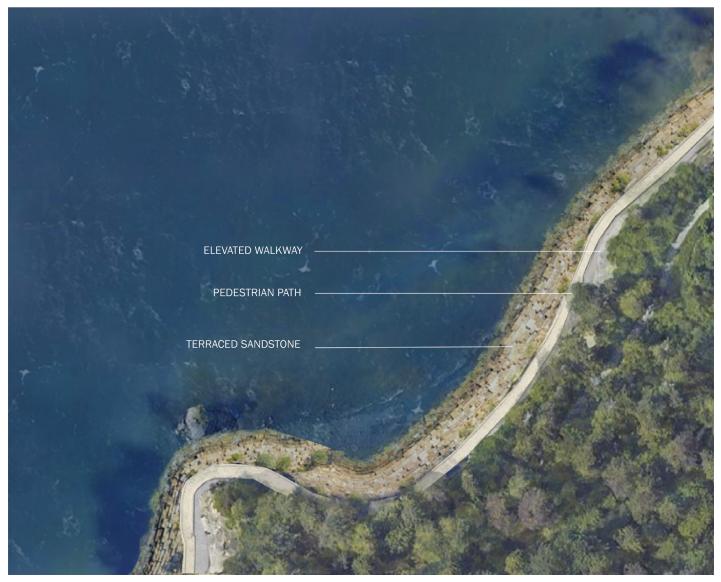
Figure 51: Proposed site plan

+ An elevated walkway wraps around cliffs that provides a coastal pathway year-round during extreme high tide events and an alternate path if maintenance is needed for sandstone infrastructure below.
