# UBC Vancouver Green Rainwater Infrastructure Mapping and Asset Management

Prepared by: Eric Fang, Heather Li, Jessy Lin, and Ewan Painter  
Prepared for: UBC SEEDS and UBC Campus + Community  
Planning  
ENVR 400: Community Project in Environmental Science  
The University of British Columbia

April 13<sup>th</sup>, 2025

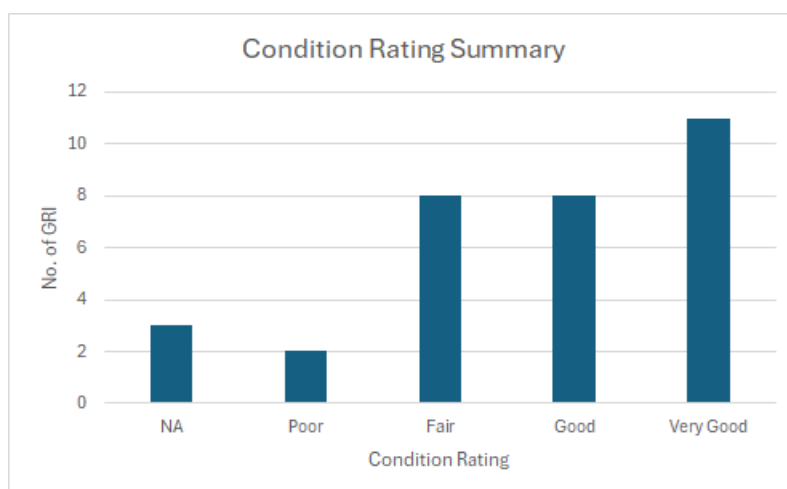
Each GRI was scored according to the condition rating criteria (Appendix C). The distribution of the results are summarized in Figure 5. GRI #4, 24, and 25 are listed as NA as they were inaccessible.

**Figure 7.** Distribution of condition rating across 33 GRI around UBC campus.
